FINAL REPORT | December 31, 2014

FHWA Request to Experiment 2014 Final Evaluation Report

Prepared for
City of Edina
Department of Public Works
7450 Metro Boulevard
Edina, MN 55439

Prepared by
Alliant Engineering, Inc.
233 Park Avenue S, Suite 300
Minneapolis, MN 55415
612-758-3080

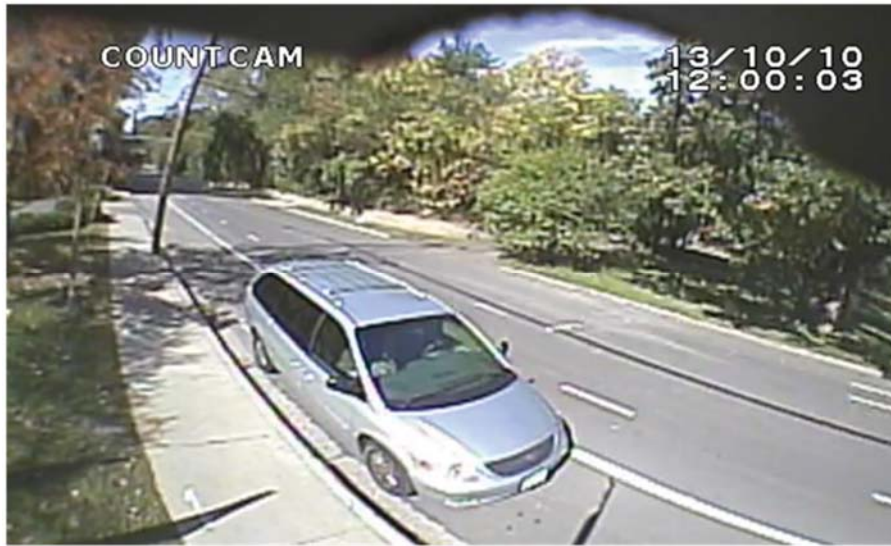
Figure 2. West 54th Street near Halifax Avenue Camera View

West 54th Street has symmetric lane geometry, consisting of an 8 foot parking lane with a solid white stripe and a 5 foot wide bike lane. The bike lane has a bicycle symbol with arrow message and a dashed white stripe on the left side of the lane. The two-way traffic center space is 14 feet wide and does not have a centerline.

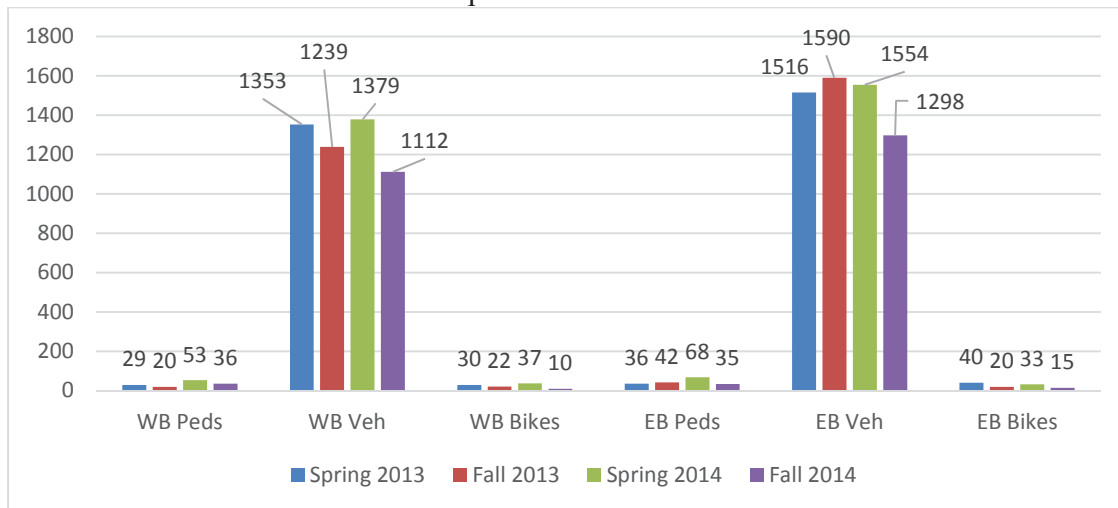
Figure 3. West 54th Street 24-Hour Volumes

Figure 3 shows the 24-hour vehicle, pedestrian and bicycle volumes collected on West 54th Street for each of the evaluation periods.

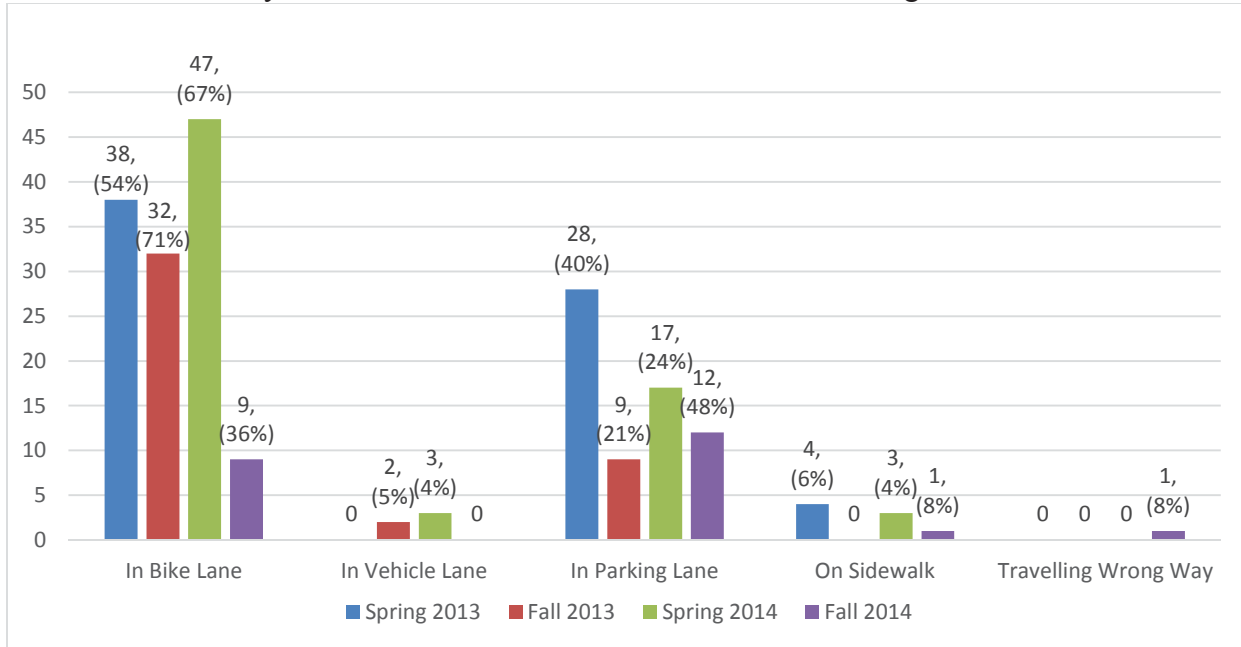
Figure 4. West 54th Street Bicycle Lane Positioning

Figure 4 summarizes the observed bicyclist lane positioning. The study found that the majority of bicyclists used the bike lane, however a large percentage still traveled in the parking lane as long as there was no vehicle present. This is acceptable as the extra space allows for a greater perceived safety by the bicyclists. The study also shows that a very small number of bicyclists travel on the sidewalk or travel in the wrong direction.

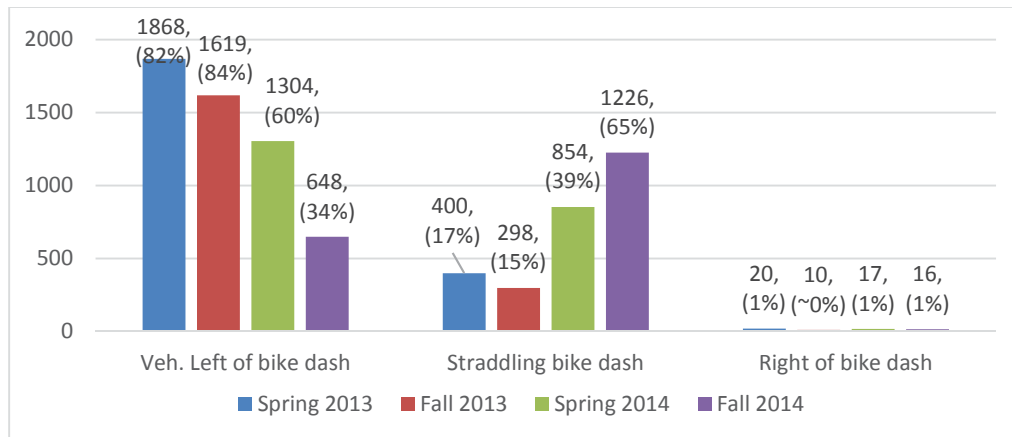
Figure 5. West 54th Street Single Vehicle Behavior

Figure 5 summarizes the motor vehicle lane positioning when only one vehicle is present (no conflict). The data shows that over time, vehicles that lie completely to the left of the bike dash reduce, while the number of vehicles that straddle the bike dash increases. This change represents a growing comfortability with the design that complies with the intended operation (vehicles can use advisory lanes, so long as no bicycles are present). This occurrence may have an indirect correlation with more bicyclists riding in the parking lane.

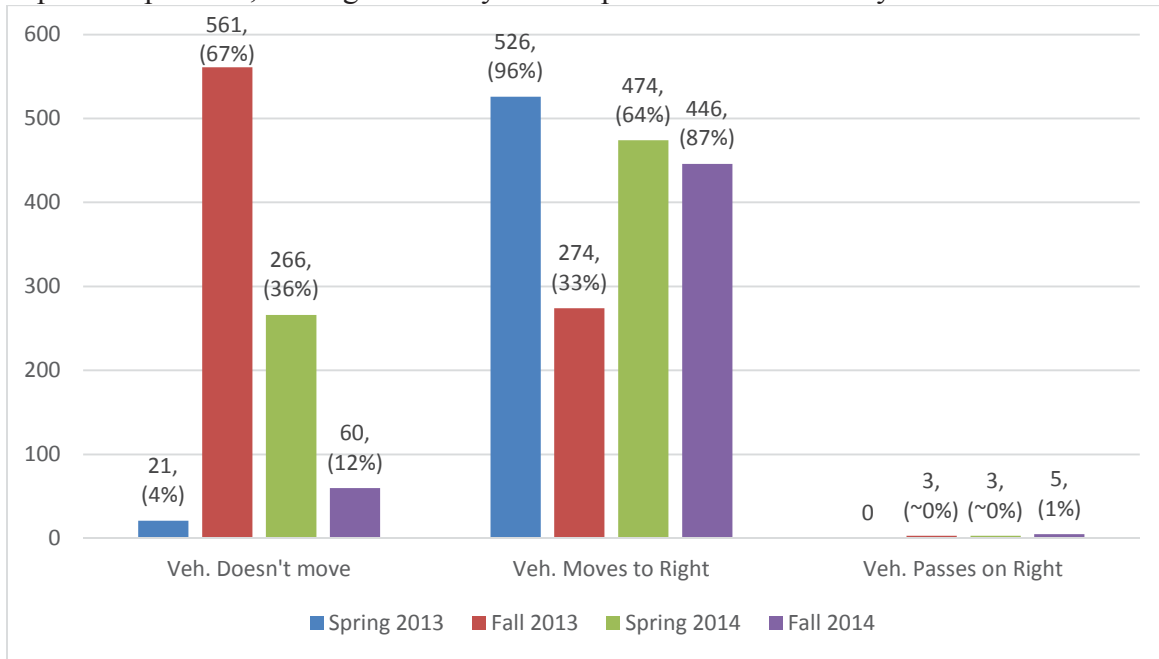
Figure 6. West 54th Street Vehicle Meeting Oncoming Vehicle Behavior

Figure 6 summarizes the motorist’s behavior when approaching an oncoming vehicle. The data does not show a consistent trend; however, for the most part the motorist moves to the right when meeting an oncoming vehicle. This complies with the intended and expected operation, so long as no bicycles are present in the advisory lane.

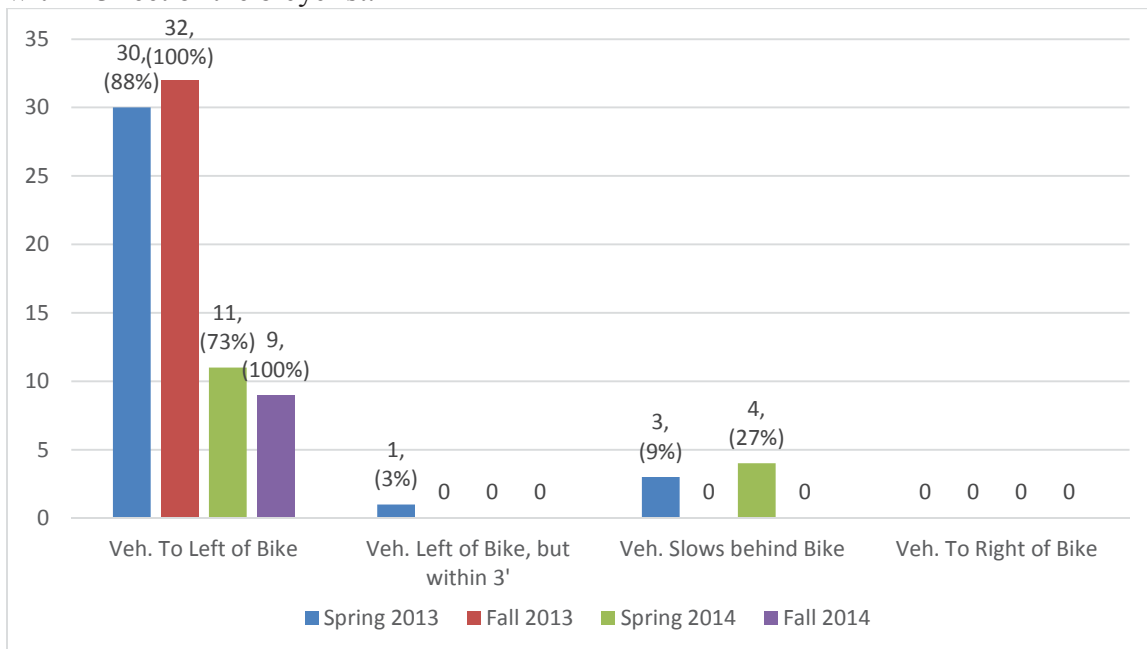
Figure 7. West 54th Street Vehicle Meeting Bicycle (in Same Direction)

Figure 7 summarizes the vehicle behavior when a bicycle is present. The data shows an excellent compliance with the intended operation, with only one vehicle observed passing within 3 feet of the bicyclist.

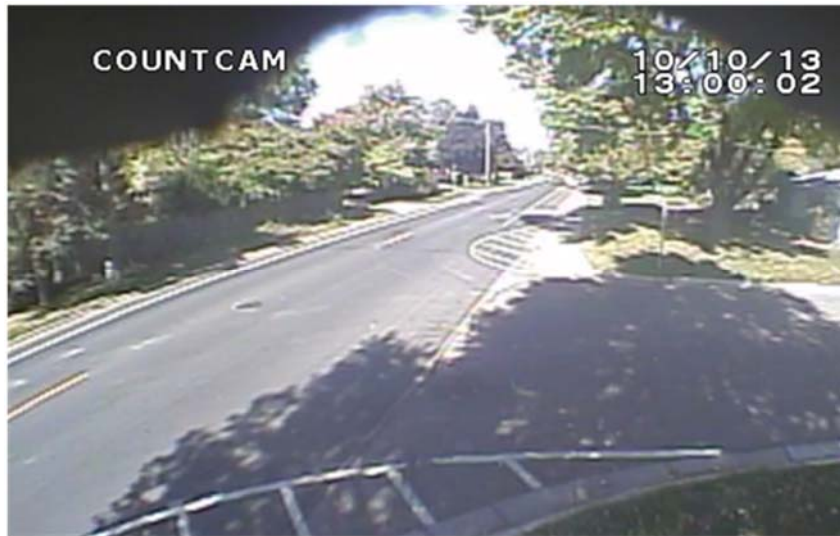
Figure 8. Wooddale Avenue at West 55th Street Camera View

Wooddale Avenue was evaluated under two separate design scenarios – advisory bike lanes and shared lane markings. The Spring 2013 evaluation period consisted of an advisory bike lane design, with the parking on the northbound side of the road only. The section evaluated under the Fall 2013-Fall 2014 period consisted of an asymmetric geometry, with the northbound direction containing an 8 foot vehicle parking lane with a solid white line to designate the end width, and a shared lane marking within the 12 foot travel lane. The southbound direction has a 5 foot designated bicycle lane (with white bicycle symbol and arrow), and an 11 foot vehicle travel lane. A dashed yellow centerline is present.

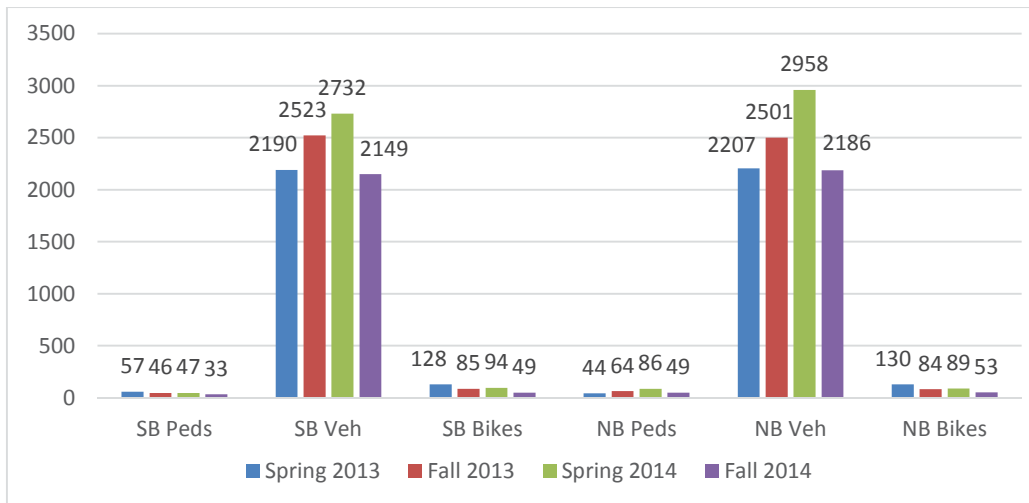
Figure 9. Wooddale Avenue at 55th Street 24-Hour Volumes

Note: Advisory bike lanes were in place during the Spring 2013 evaluation period. Figure 9 shows the 24-hour vehicle, pedestrian and bicycle volumes collected on Wooddale Avenue.

Note: Advisory bike lanes were in place during the Spring 2013 evaluation period.

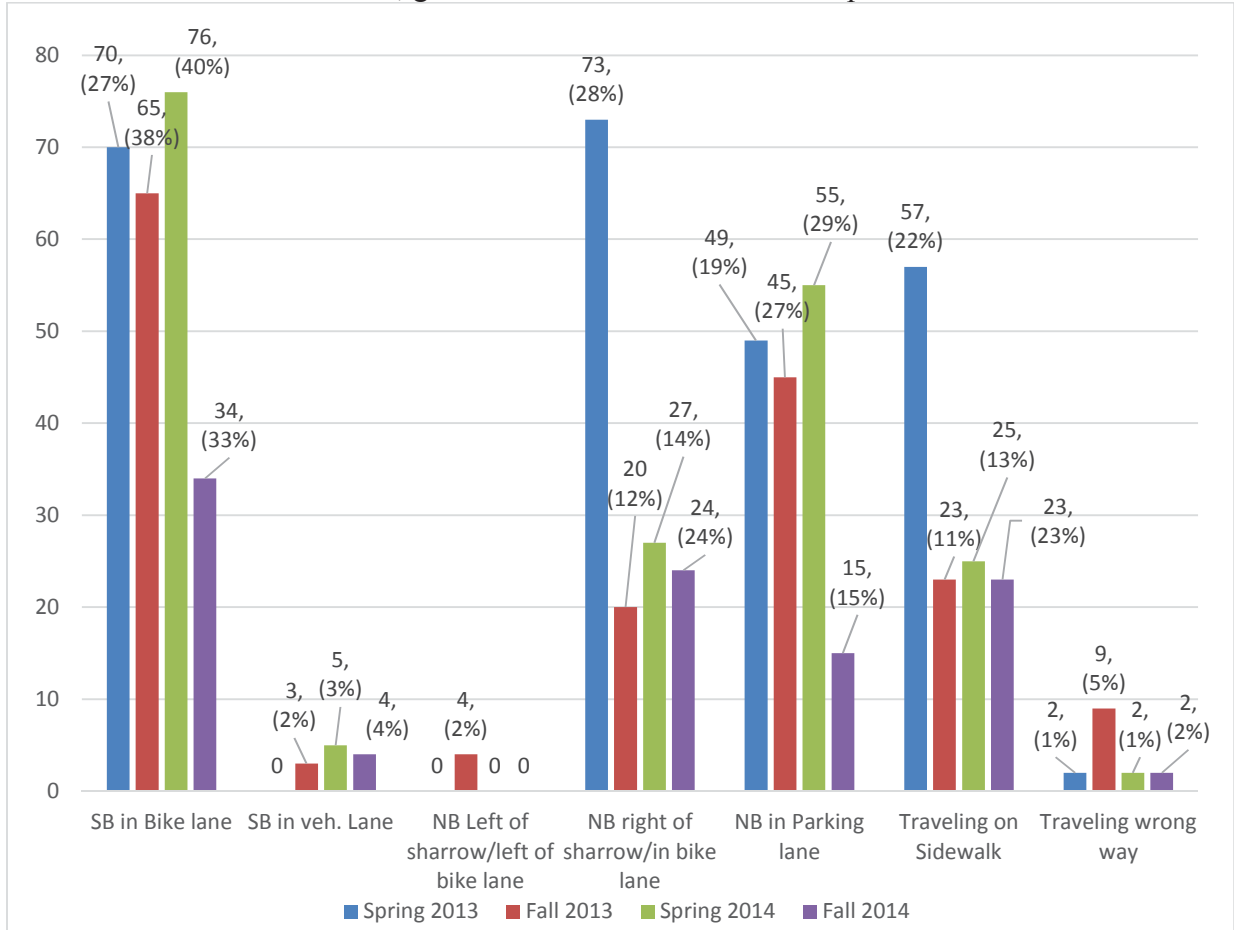
Figure 10. Wooddale Avenue at 55th Street Bicycle Lane Positioning

Figure 10 summarizes the observed bicyclist lane position by direction. The data shows excellent compliance by bicycles in the southbound direction, with the strong majority of southbound bicyclists using the bike lane. In the northbound direction, the data shows a large number of bicyclists using the parking lane when no vehicles were parked, with a much higher percentage occurring under the shared lane markings design. This seems to be caused by an increase in the perceived safety of the bicyclists by offering additional buffer clearance from vehicles, given a dedicated bike lane is not provided.

Note: Advisory bike lanes were in place during the Spring 2013 evaluation period.

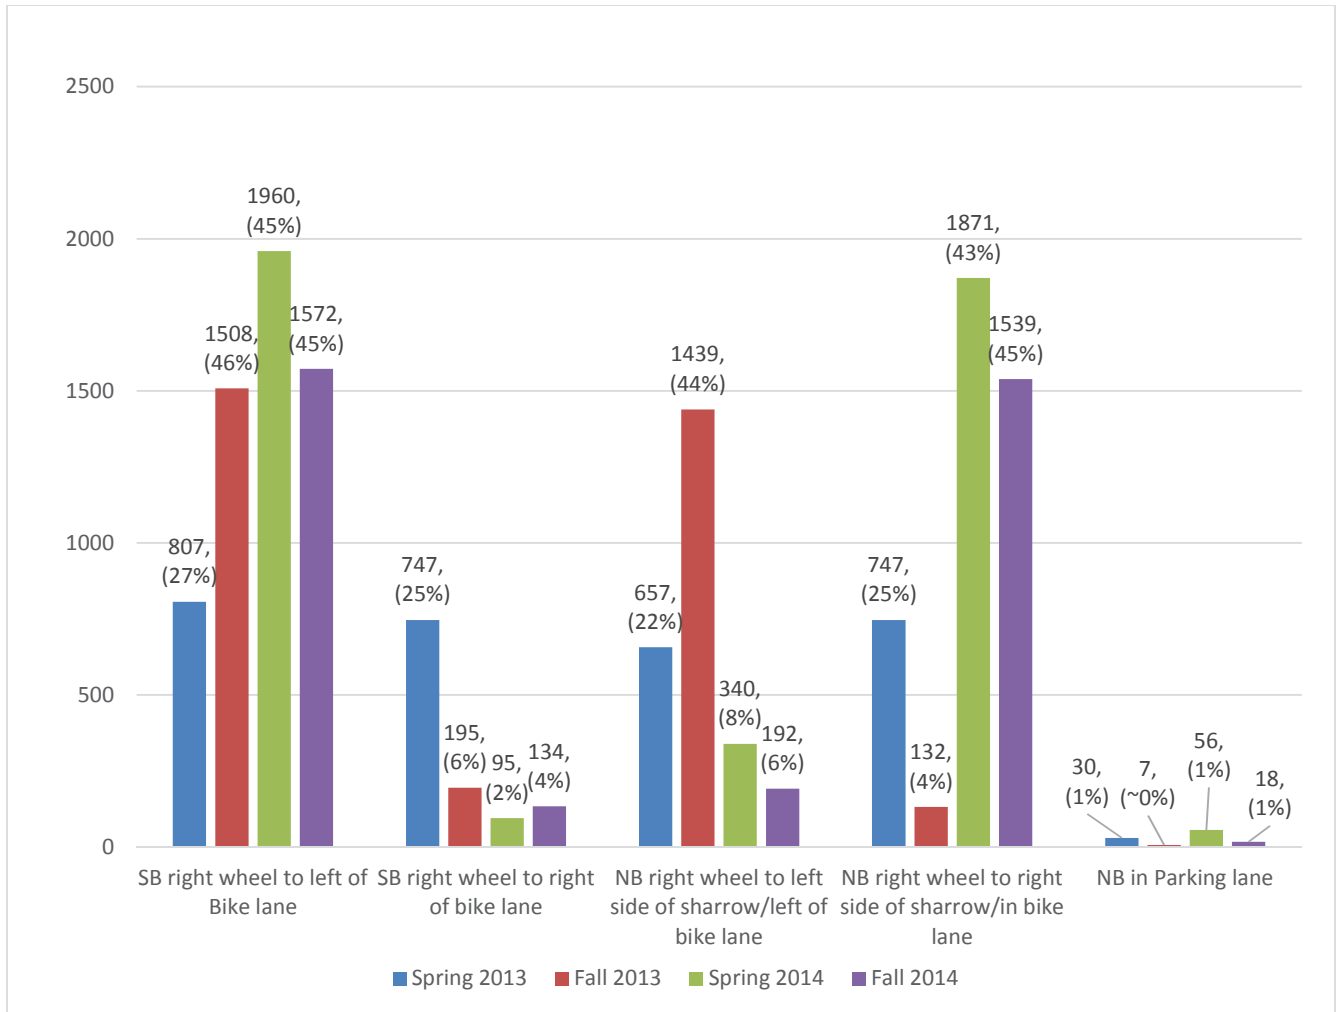
Figure 11. Wooddale Ave at 55th Street Single Vehicle Behavior

Figure 11 summarizes the motorist behavior when no other vehicles or bicyclists were present. In the southbound direction, compliance with the intended operation (vehicles traveling in the center of the travel lane) increases over time as vehicles become more comfortable with the design. The same was observed in the northbound direction. At the time of the shared lane marking implementation (Fall 2013), most northbound vehicles drove to the left of the shared lane marking, but over time the motorist position shifted rightward (i.e. traveling in the center of the drive lane as long as no bicyclists were present).

Note: Advisory bike lanes were in place during the Spring 2013 evaluation period.

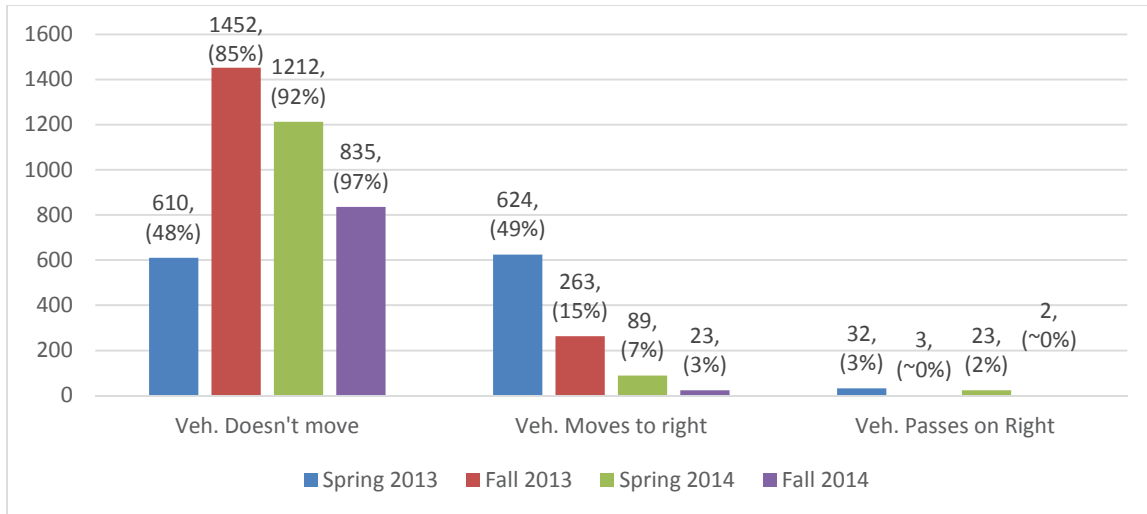
Figure 12. Wooddale Avenue at 55th Street Vehicle Meeting Oncoming Vehicle Behavior

Figure 12 summarizes how the motorists reacted to another oncoming vehicle. A broken yellow centerline was in place during the Fall 2013 – Fall 2014 evaluation periods. As a result, the data shows motorists experienced a much improved sense of comfort in the travel lane, though still less than 100 percent. The data shows that over time, fewer vehicles move to the right when an oncoming vehicle approaches, suggesting the drivers have become more comfortable with the space provided.

Note: Advisory bike lanes were in place during the Spring 2013 evaluation period.

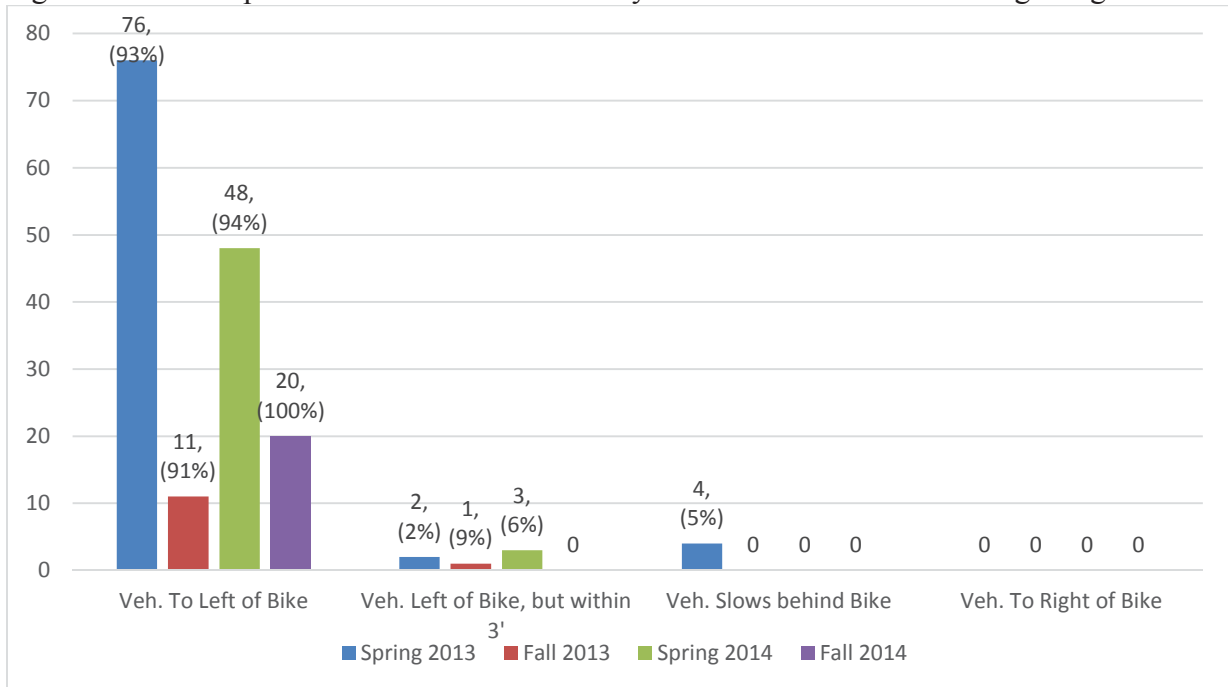
Figure 13. Wooddale Avenue at 55th Street Vehicle Meeting Bicycle (in Same Direction)

Figure 13 summarizes the occurrences of vehicles reacting to bicyclists. The data shows high levels of compliance under both the advisory lane and shared lane marking designs.

Note: Advisory bike lanes were in place during the Spring 2013 evaluation period.

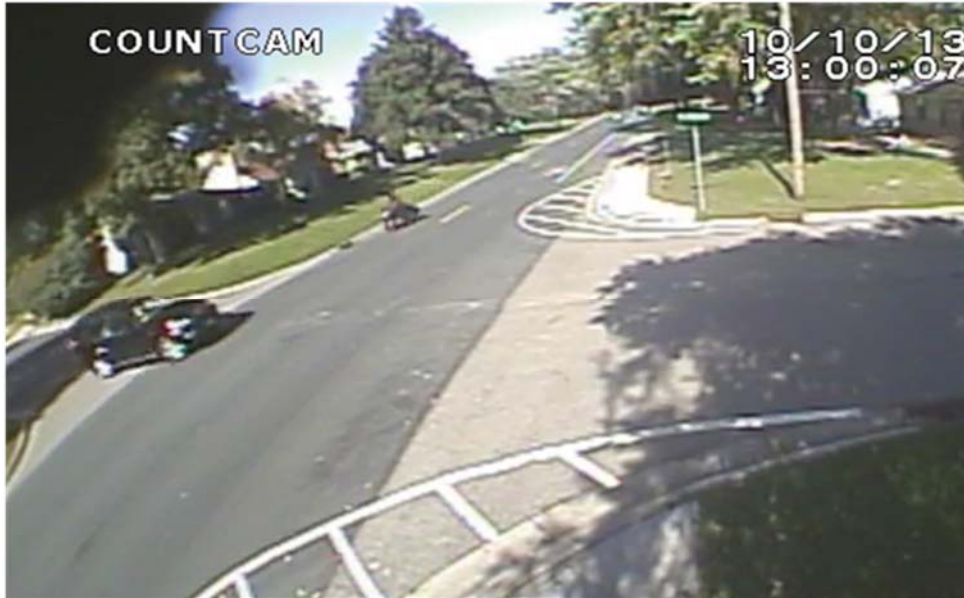
Figure 14. Wooddale Avenue at West 60th Street Camera View

Wooddale Avenue was evaluated under two separate design scenarios – advisory bike lanes and shared lane markings. The Spring 2013 evaluation period consisted of an advisory bike lane design, with the parking on the northbound side of the road only. The section evaluated under the Fall 2013-Fall 2014 period consisted of an asymmetric geometry with both the northbound and southbound vehicle travel lanes containing a shared lane marking. An 8 foot parking lane is provided in the northbound direction. Parking does not exist in the southbound direction, so the shared lane marking is located approximately 4 feet from the face of curb. A dashed yellow centerline is present.

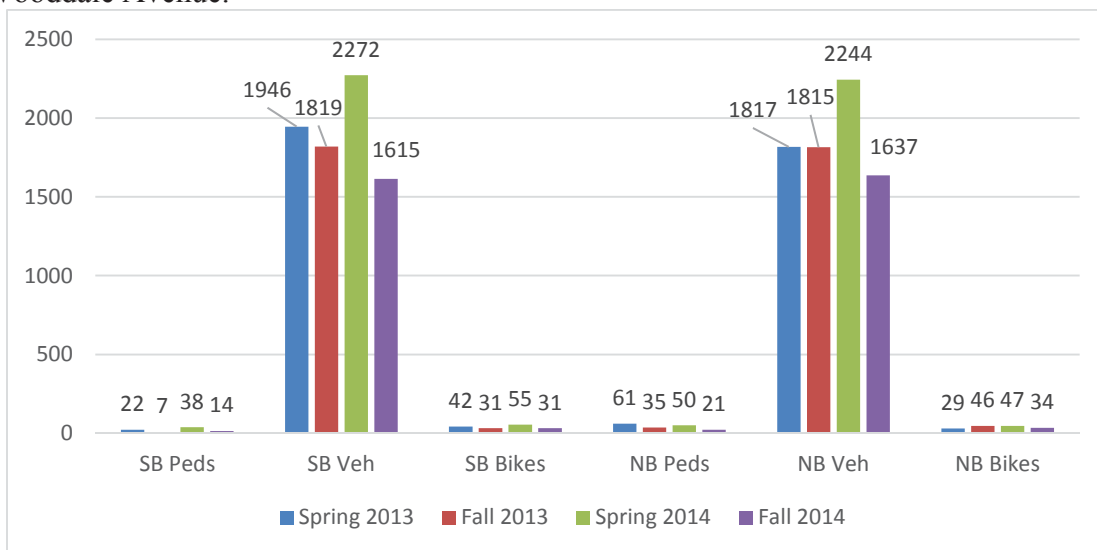
Figure 15. Wooddale Avenue at 60th Street Volumes

Figure 15 shows the 24-hour vehicle, pedestrian and bicycle volumes collected on Wooddale Avenue.

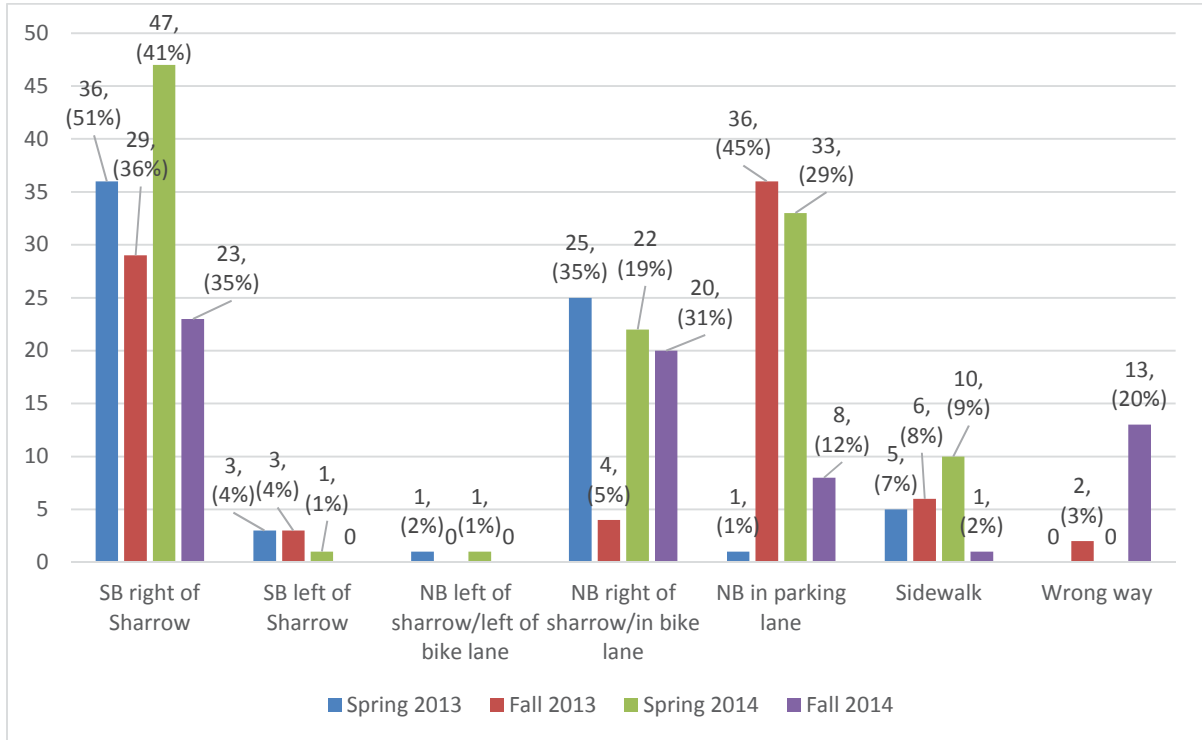
Figure 16. Wooddale Avenue at 60th Street Bicycle Lane Positioning

Figure 16 summarizes the observed bicyclist lane positions by direction. The data shows that the bicyclists were best positioned under the advisory lane design. At the time of the switch to the shared lane markings, it can be suggested that bicycle position improved over time, as shown by the decreasing number of bicyclists riding in the parking lane; however, bicyclists appear to be less comfortable riding in the shared travel lane.

Note: Advisory bike lanes were in place during the Spring 2013 evaluation period

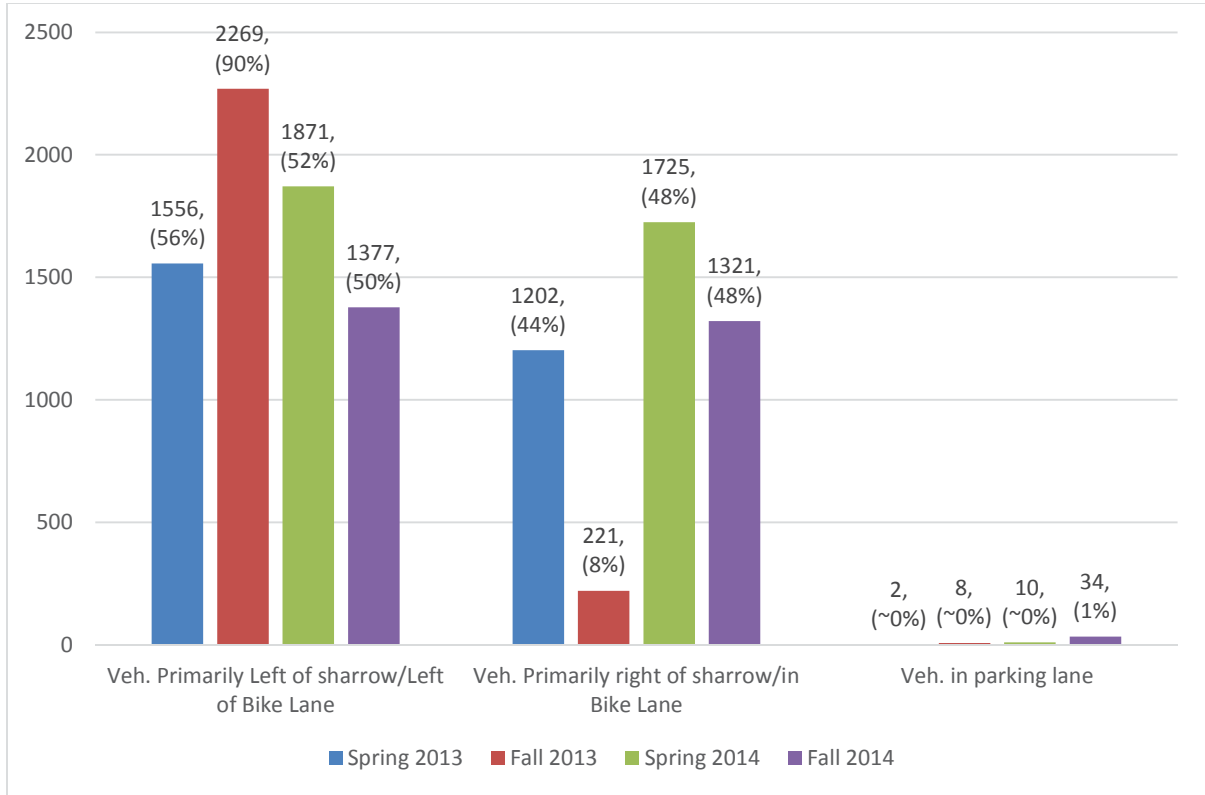
Figure 17. 60th and Wooddale Single Vehicle Behavior

Figure 17 summarizes the motorist’s behavior when no other vehicles or bicyclists are present. In the southbound direction, the motorists tended to navigate rightward in the lane over time. The Fall 2014 evaluation period found the motorists traveling in similar position on the roadway between the advisory lane and shared lane marking conditions. The same observation was found for the northbound direction.

Note: Advisory bike lanes were in place during the Spring 2013 evaluation period

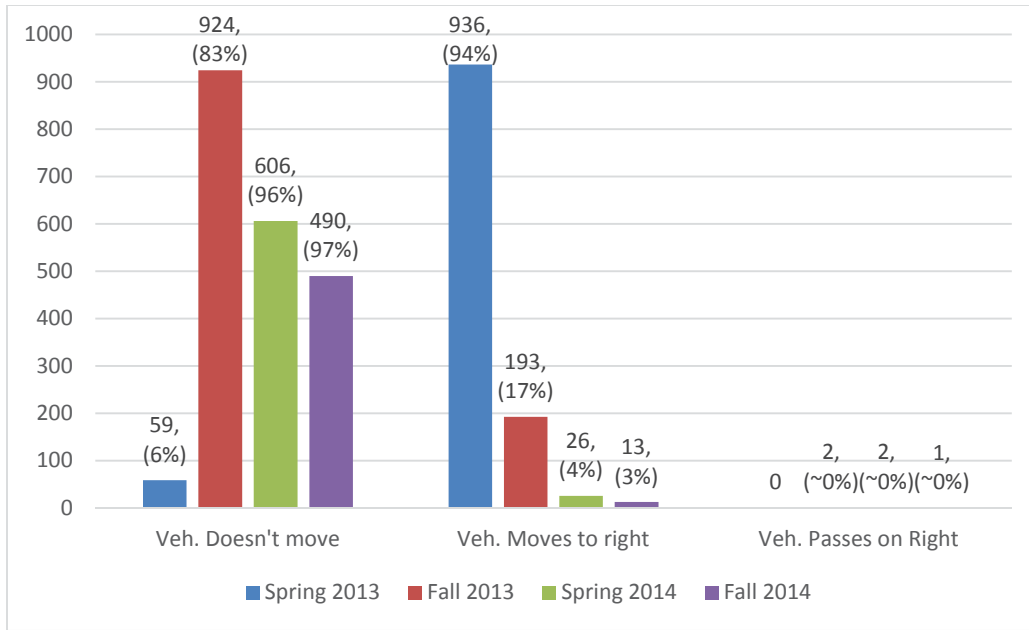
Figure 18. Wooddale Avenue at 60th Street Vehicle Meeting another Oncoming Vehicle Behavior

Figure 18 summarizes the behavior of motorists that approached oncoming vehicles. Although the overall travel way space is the same, it can be seen from the percentages that the presence of a yellow centerline has a dramatic influence on the perceived comfort of the motorist. Under the shared lane marking design, the motorists tended to not adjust their lane position, whereas the majority of motorists on the advisory lane tended to drift rightward.

Note: Advisory bike lanes were in place during the Spring 2013 evaluation period

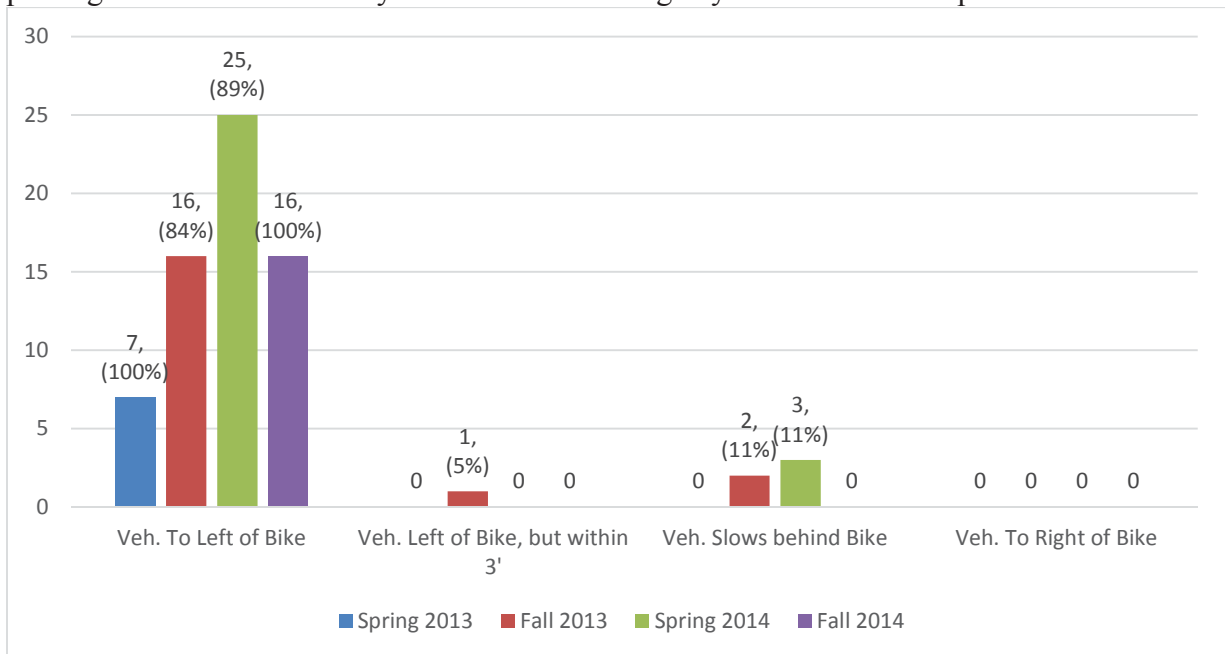
Figure 19. Wooddale Avenue at 60th Street Vehicle Meeting Bicycle (in Same Direction)

Figure 19 summarizes the occurrences of when a motorist approached a bicycle and how they reacted. The data shows excellent compliance under both the advisory lane and the shared lane marking designs. It is also noted that only one observation of a motorist passing within 3 feet of a bicyclist was made during any of the evaluation periods.

Note: Advisory bike lanes were in place during the Spring 2013 evaluation period

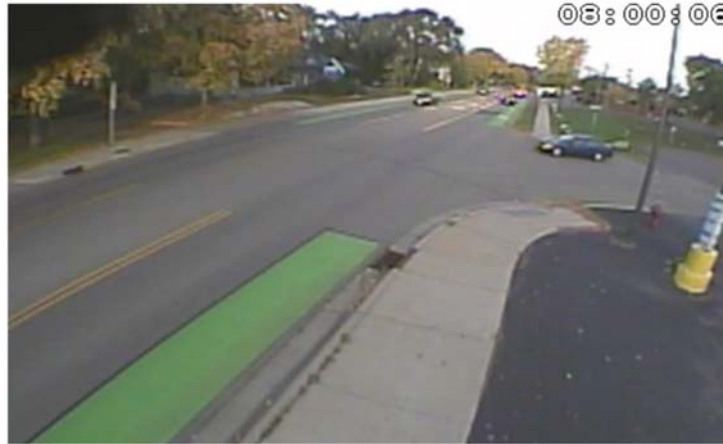
Figure 20. Valley View Road Camera View

The segment of Valley View Road between Wooddale Avenue and Kellogg Boulevard consists of a three lane cross-section (two way center left turn lane) and a four foot wide green colored continuous shared bicycle lane located within the 14 foot wide eastbound and westbound travel lanes.

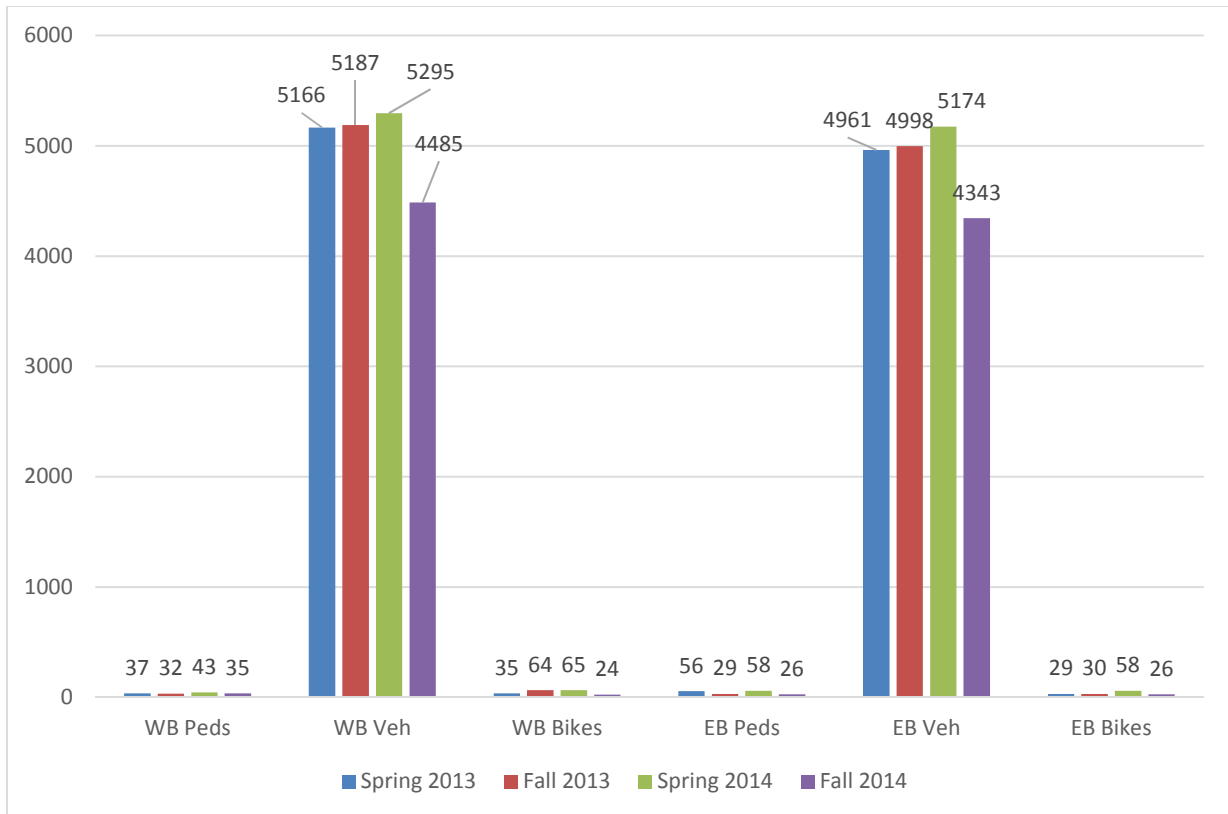
Figure 21. Valley View Road Volumes

Figure 21 shows the 24-hour vehicle, pedestrian and bicycle volumes collected on Valley View Road.

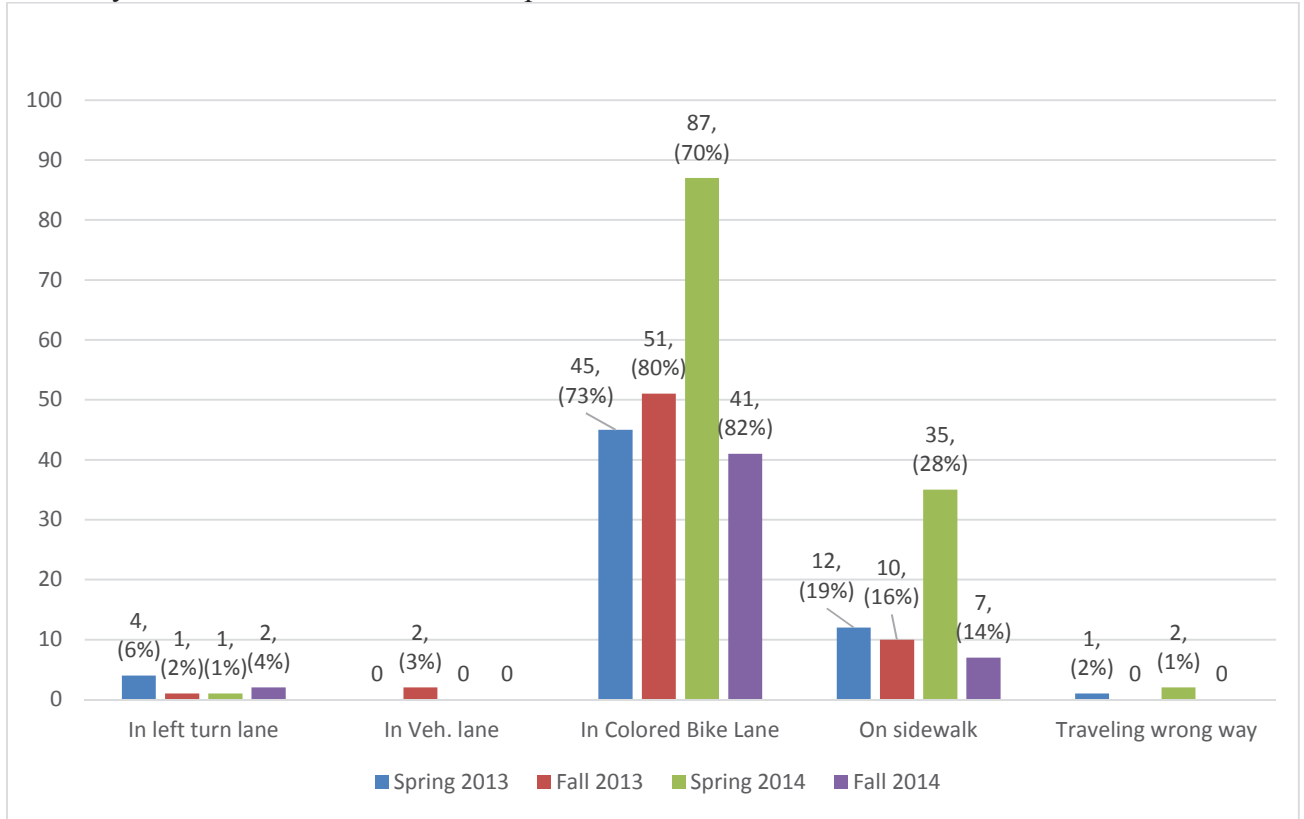
Figure 22. Valley View Rd and Kellogg Bicycle Lane Positioning

Figure 22 summarizes the observed bicyclist lane positions, which was found to be relatively consistent over the evaluation periods.

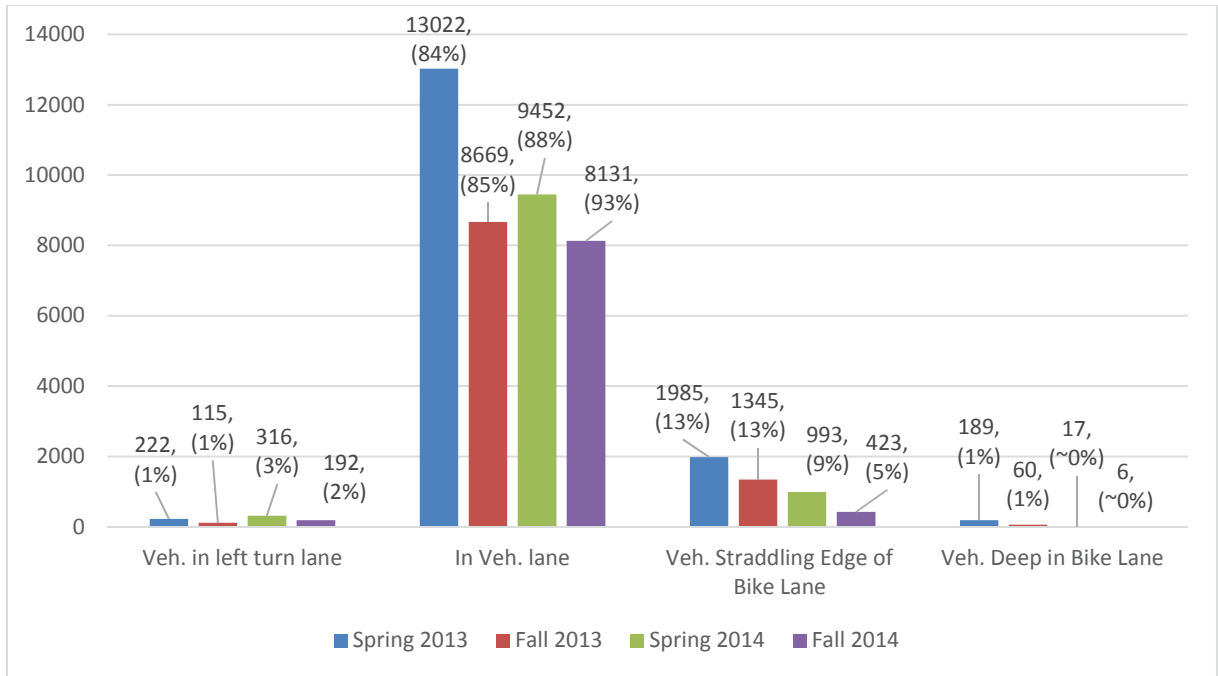
Figure 23. Valley View Road Single Vehicle Behavior

Figure 23 summarizes the behavior of single vehicle motorists along Valley View Road. As shown by the data, the motorist travels predominately to the left of the colored shared bike lane markings. Comparing this observation with observations of shared lane markings on Wooddale Avenue, the colored shared lane exhibits much improved vehicle lane position. However, this observation may be skewed due to the presence of an adjacent two way center left turn lane as opposed to an opposing through lane.

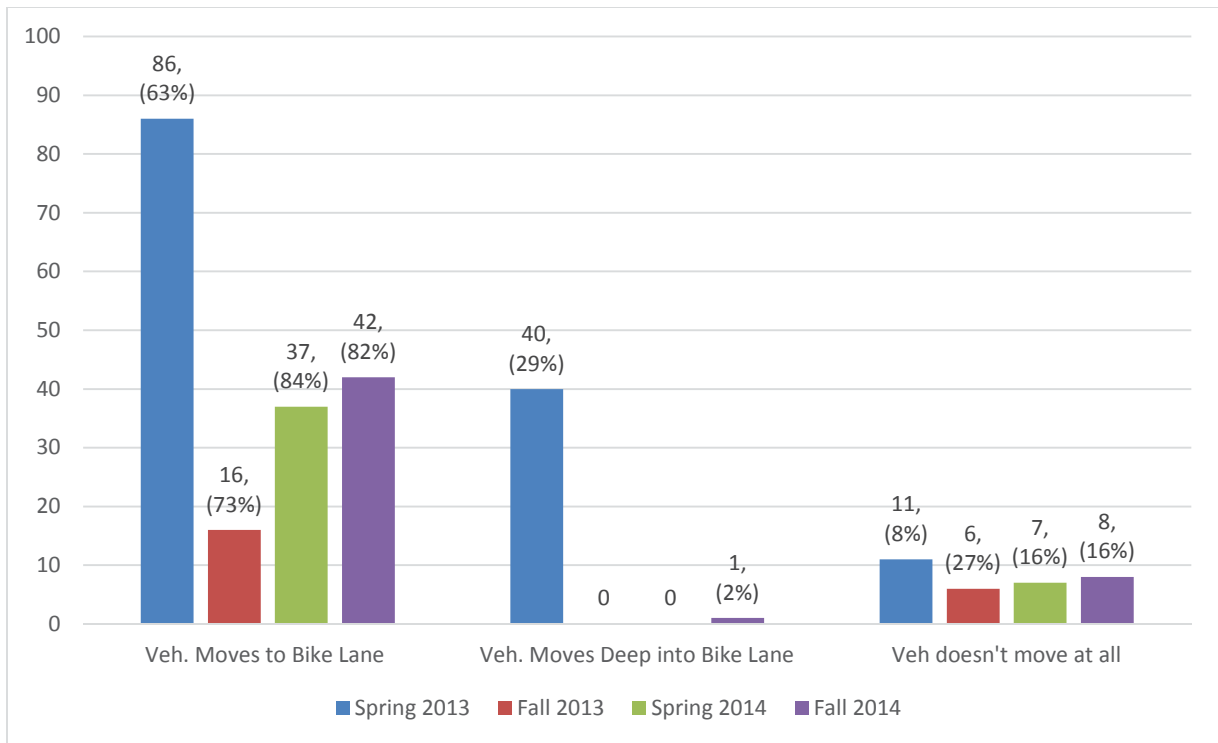
Figure 24. Valley View Road Vehicles Reacting to Left Turning Vehicles

Figure 24 summarizes the reactions of motorists to oncoming vehicles using the center left turn lane.

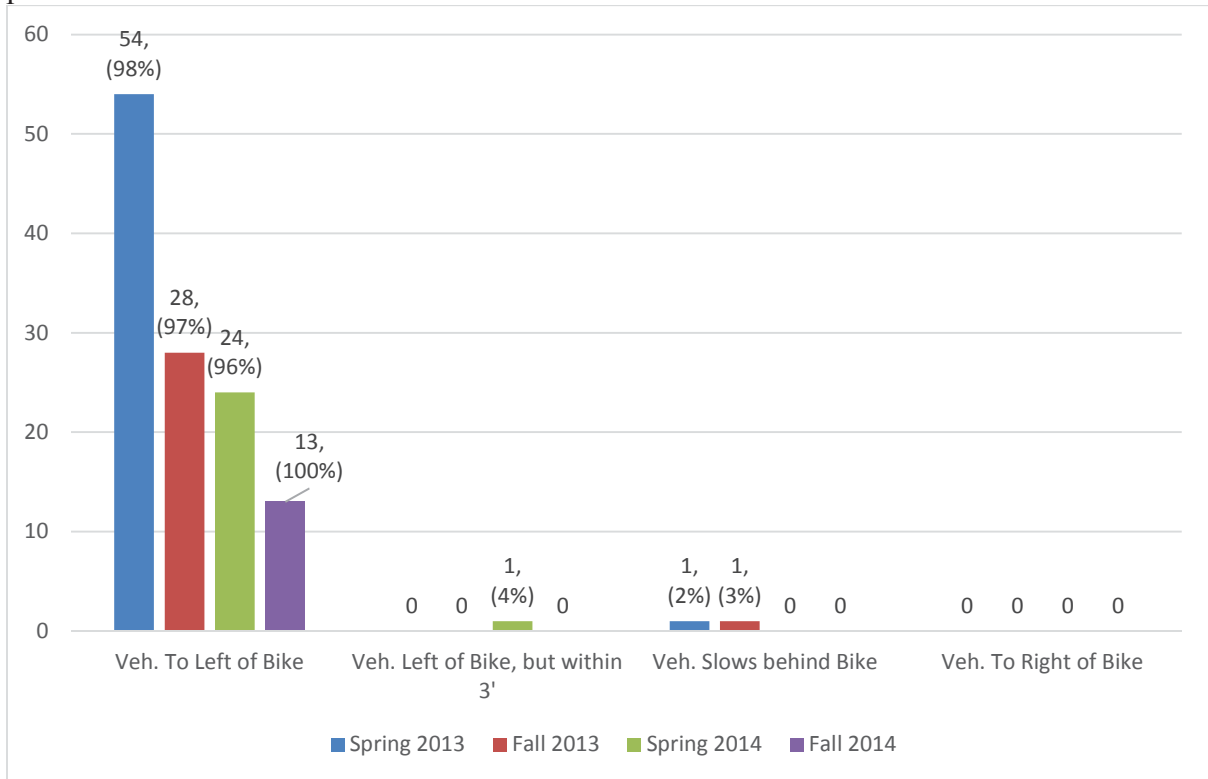
Figure 25. Valley View Road Vehicle Meeting a Bicyclist (in Same Direction)

Figure 25 summarizes the behavior of motorists when approaching a bicyclist. As shown by the percentages, motorists are observed safely passing bicyclists. Only 1 observation of a motorist passing a bicyclist within 3 feet was made over the two year evaluation period.

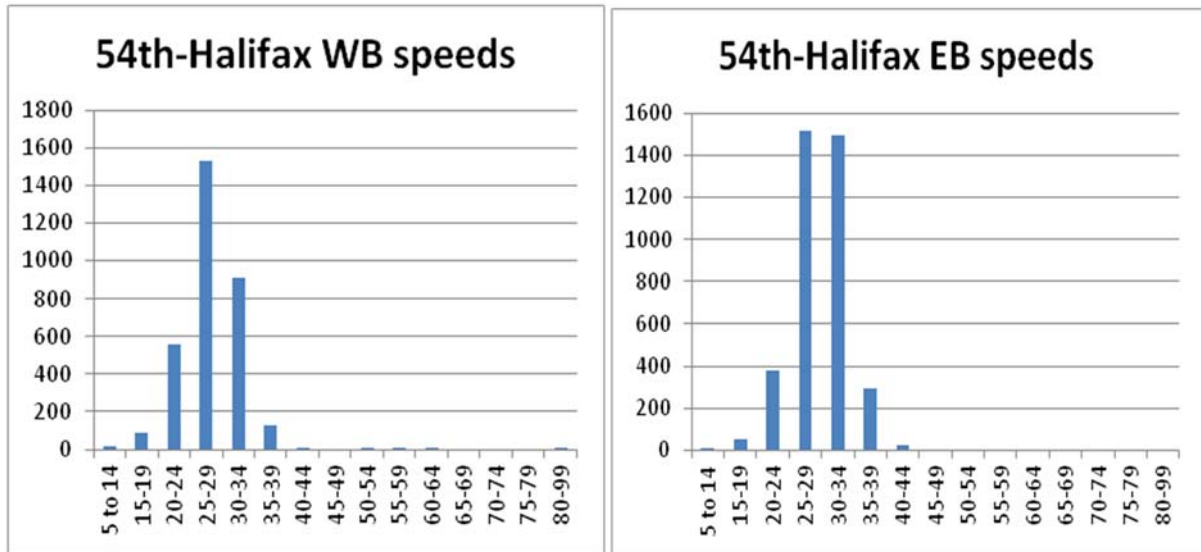
West 54th Street has a 30 mph posted speed limit. Table 1 summarizes the results of the speed study.

Note: Speed Study conducted in November 2013 (Advisory Bicycle Lane Present)

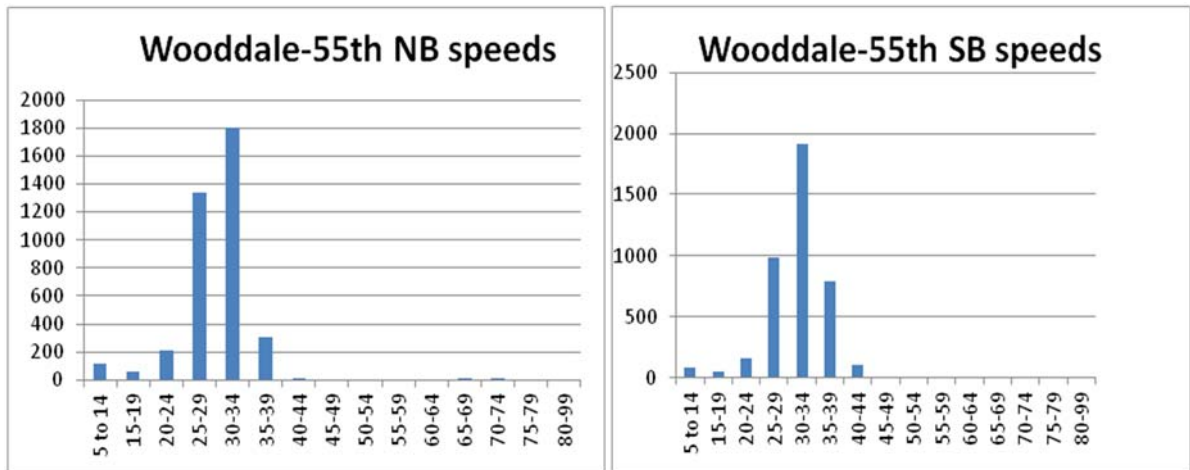
Table 2 summarizes the speed study conducted for the Wooddale Avenue at 55th Street location. Wooddale Avenue has a 30 mph posted speed limit. Table 2 also compares the Fall 2013 speed study results to the previous years’ pavement marking and lane assignment scenarios. The before data (2012 and 2011) was collected by the City of Edina.

Note: 2013 data collected in November 2013 (Bicycle Lane / Shared Lane Markings present). The 2012 data was collected in October 2012 immediately following the Advisory Bicycle Lane installation. The 2011 data representing the original pavement marking condition (two travel lanes separated by centerline and one on-street parking lane delineated with a solid white edge line) was not available.
