FINAL REPORT | December 31, 2014

FHWA Request to Experiment 2014 Final Evaluation Report

Prepared for
City of Edina
Department of Public Works
7450 Metro Boulevard
Edina, MN 55439

Prepared by
Alliant Engineering, Inc.
233 Park Avenue S, Suite 300
Minneapolis, MN 55415
612-758-3080

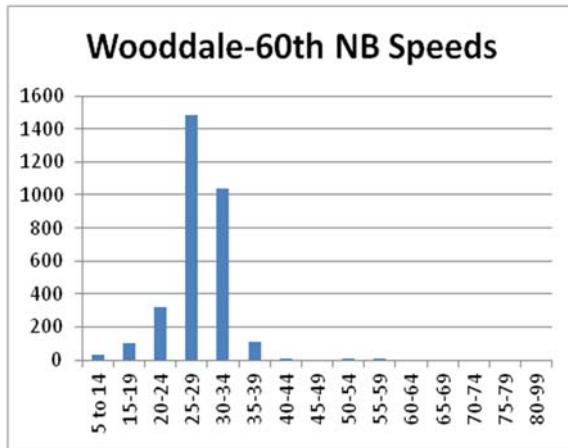
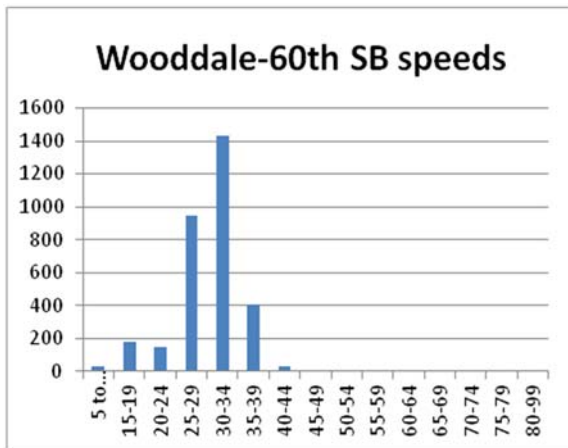
The speed data for the 60th Street and Wooddale Avenue location is shown in Table 3. Just as with the Wooddale Avenue and 55th Street location, a before and after comparison was performed using past speed data obtained by the City of Edina. The posted speed limit is 30 mph.

Note: 2013 data collected in November 2013 (Bicycle Lane / Shared Lane Markings present). The 2012 data was collected in October 2012 immediately following the Advisory Bicycle Lane installation. The 2011 data represents the original pavement marking condition (two travel lanes separated by centerline and one on-street parking lane delineated with a solid white edge line).

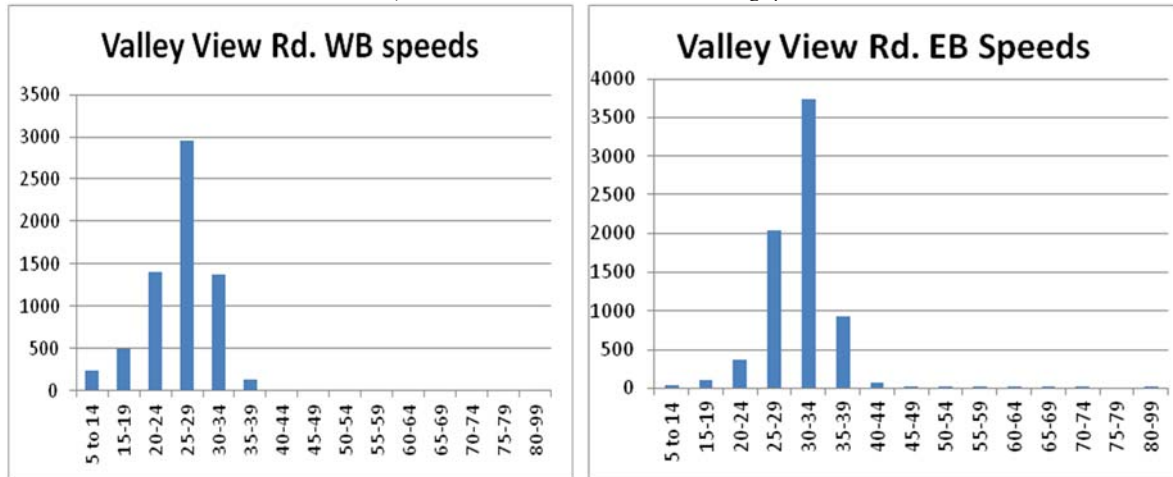
The speed data for Valley View Road, near Kellogg Boulevard, is summarized in Table 4. The posted speed limit is 30 mph.

Note: 2013 data collected in November 2013 (Continuous Colored Shared Lane markings present. 2012 and 2011 data not available.
