Chapter 7

Advisory Bicycle Lanes

Grant Street East/14th Street East between Portland Avenue South and 11th Avenue South

The purpose of this chapter is to fulfill the final evaluation reporting requirements of the Federal Highway Administration's approval to experiment 9(09)-6(E) – Bicycle Markings and Signals – Minneapolis, MN.

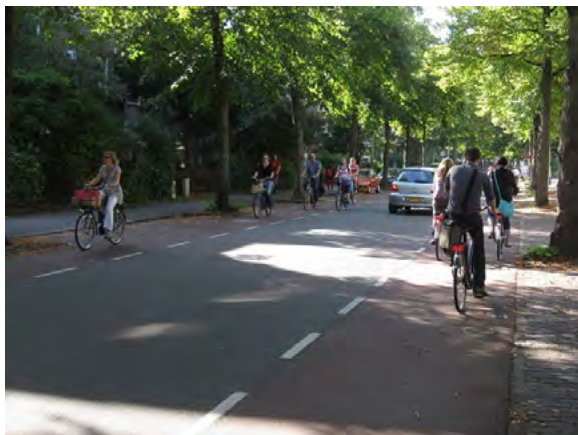
Figure 7-3: Example of bicyclists traveling on a street with advisory bicycle lanes in Utrecht, Netherlands

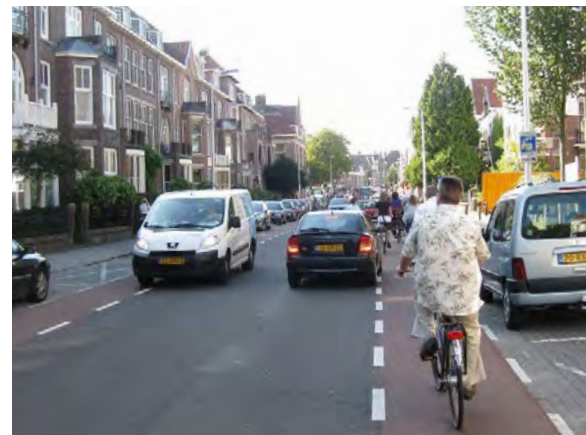
Figure 7-4: Example of two oncoming motorists negotiating on a street with advisory bicycle lanes in Utrecht, Netherlands

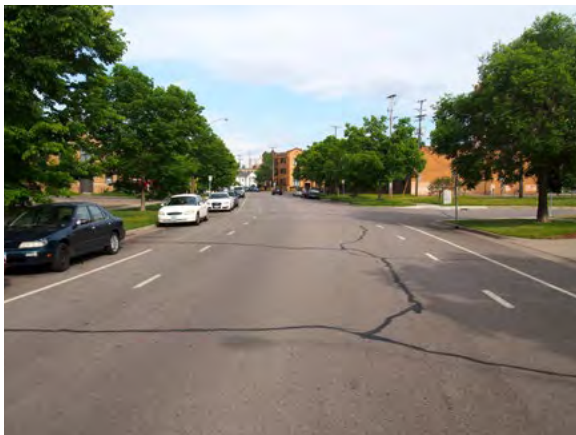
Figure 7-5: Grant Street East facing east at Portland Avenue South after installation with a 20-foot two-way travel lane

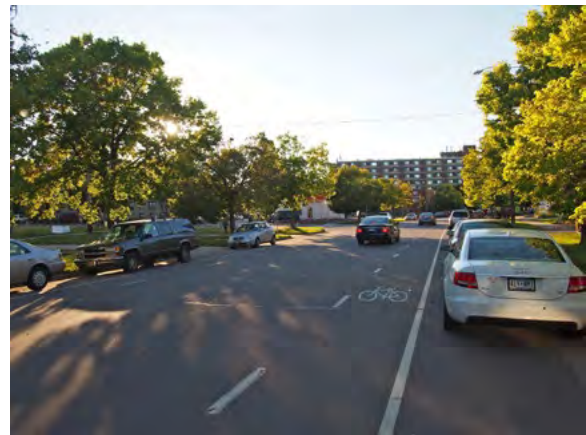
Figure 7-6: Grant Street East facing west at Park Avenue South after installation with a 20-foot two-way travel lane

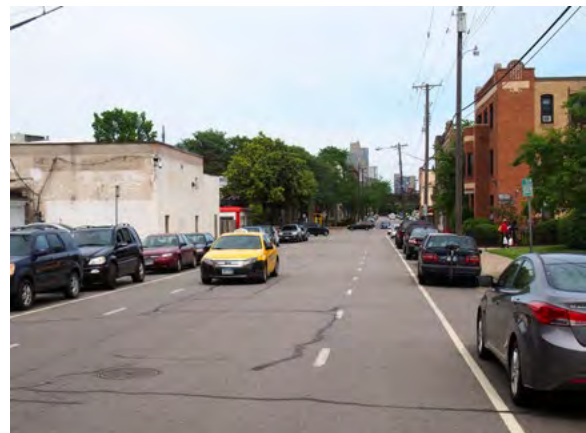
Figure 7-8: 14th Street East facing east at Park Avenue South after installation with a 14-foot two-way travel lane

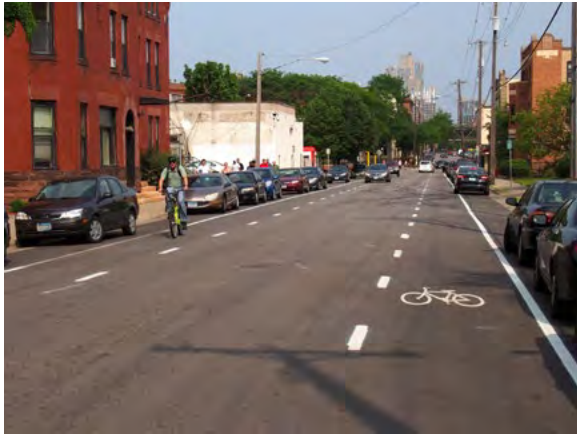
Figure 7-9: A westbound bicyclist riding on 14th Street East between Park Avenue South and Chicago Avenue South adjacent to a 14-foot two-way travel lane after installation

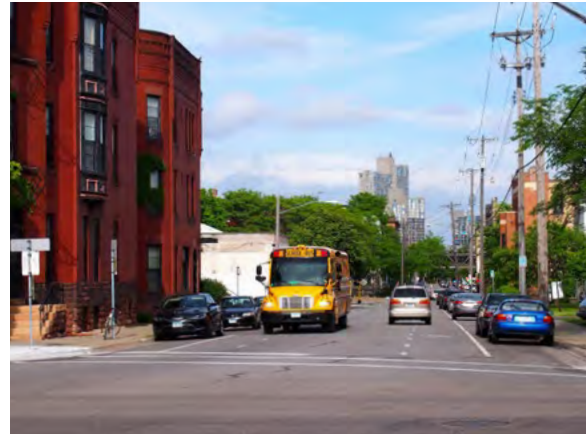
Figure 7-10: Two oncoming vehicles negotiating on 14th Street East between Park Avenue South and Chicago Avenue South within a 14-foot two-way travel lane after installation

After installation, most motorists were observed using the street as intended by operating in the two-way shared travel lane and using the advisory bicycle lane to negotiate oncoming vehicles. When no oncoming vehicle was present, 69 percent of motorists drove fully in the two-way shared travel lane, 25 percent drove with minor encroachment in the adjacent bicycle lane, and six percent drove with major encroachment into the adjacent bicycle lane. When an oncoming vehicle was present, 21 percent of motorists drove fully in the two-way shared lane, 34 percent drove with minor encroachment in the bicycle lane, and 45 percent drove with major encroachment into the bicycle lane.

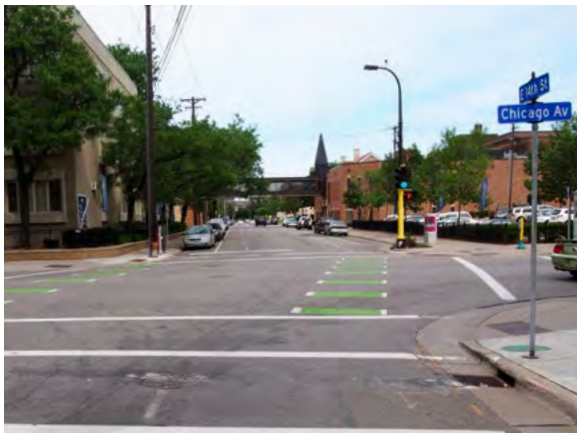
Figure 7-11: 14th Street East facing east at Chicago Avenue South after installation at the transition from a 14-foot to 18-foot two-way travel lane

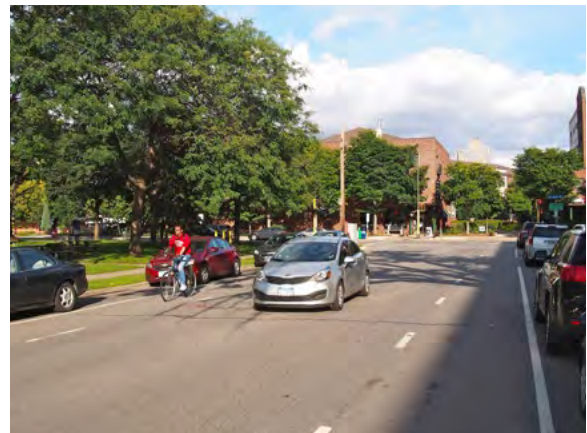
Figure 7-12: A bicyclist and motorist traveling on 14th Street East facing east towards 11th Avenue South after installation with a 18-foot two-way travel lane after installation

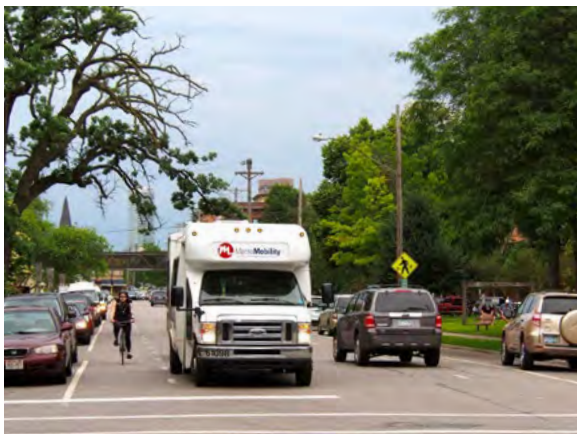
Figure 7-13: Traffic on 14th Street East at 11th Avenue South after installation with a 18-foot two-way travel lane

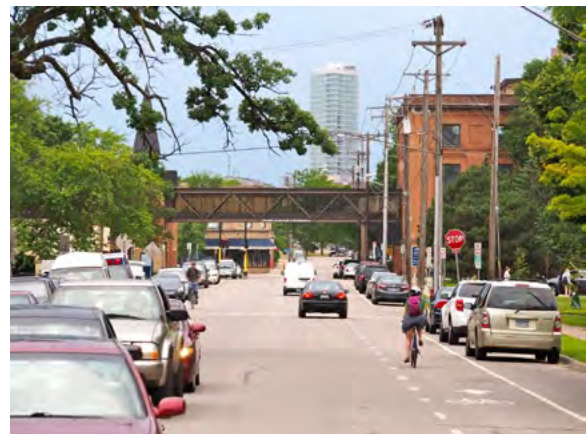
Figure 7-14: Traffic on 14th Street East between 11th Avenue South and Elliot Avenue South after installation with a 18-foot two-way travel lane

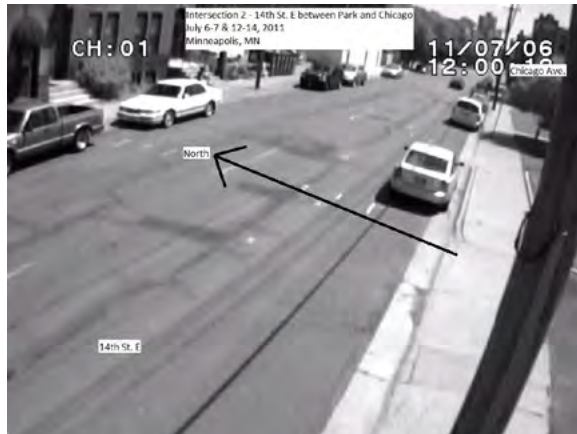
Figure 7-17: Screen capture of before video at 14th Street East between Park Avenue South and Chicago Avenue South

User behavior was evaluated before-and-after installation by recording video on 14th Street East and tabulating events. The video was recorded with an east-facing camera located on 14th Street East between Park Avenue South and Chicago Avenue South. Events tabulated include bicyclist location, motorist location, and bicyclist-motorist interactions.

Before video was collected in July of 2011 and after video was collected in May of 2012. Three 16-hour weekdays (6:00 a.m. to 10:00 p.m.) of video were processed in both the before-and-after periods. Temporary tick marks were spray painted on the roadway surface at one-foot intervals. The tick marks provided reference points to estimate the relative location of users and vehicles.

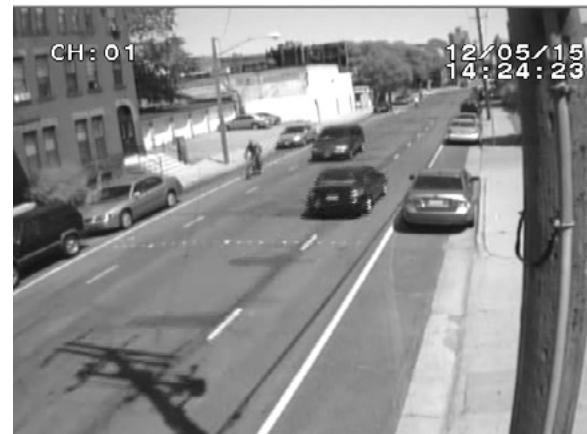
Figure 7-18: Screen capture of after video at 14th Street East between Park Avenue South and Chicago Avenue South

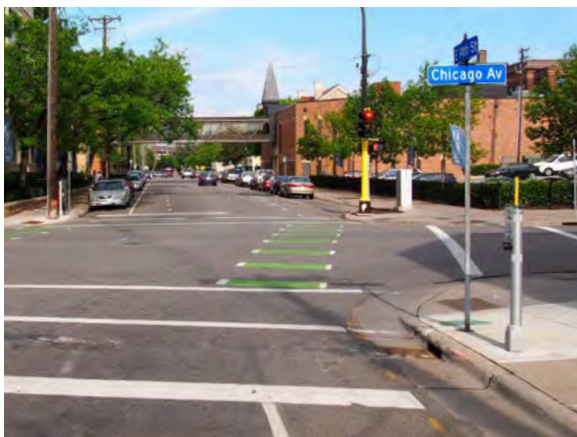
Figure 7-19: Green bicycle lane conflict markings installed on 14th Street East at Chicago Avenue South

crash. The two bicycle crashes after installation occurred under circumstances that do not appear to be a factor of the project design. After installation, there were three sideswipe and two head on crashes that occurred along Grant Street East and 14th Street. It is important to consider that these crash types occurred prior to installation and may be a factor of the offset intersections at Park Avenue South and at Chicago Avenue South. In the fall of 2015, Public Works installed green bicycle conflict markings on 14th Street East at Chicago Avenue South with the intent to reduce bicyclist-motorist conflicts. Public Works is monitoring the location to understand if the conflict markings provide guidance to bicyclists as well as motorists traveling through the offset intersection.
